METAL / NONMETAL

Serious Injury

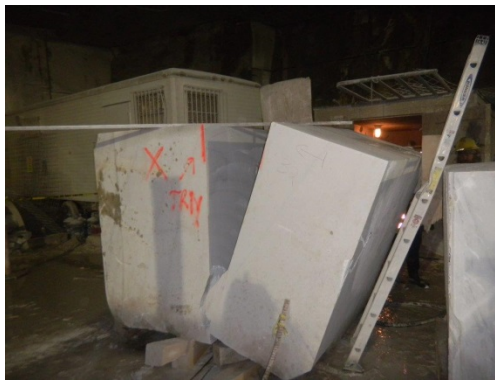
Underground Marble Mine – May 2015 – A miner was cutting a large slab of marble with a wire saw. The victim was located on a ladder repositioning a cooling water hose when the production slab split prematurely. Inadequate blocking or cribbing allowed the slab to topple toward him, pinning the victim between two slabs of marble. The victim was transported to a local hospital with crushing injuries to his legs.

- Establish and discuss safe work procedures.
- Examine work areas and identify and control all hazards before starting any work.
- Ensure material is properly blocked to prevent unexpected movement. assure energy cannot be released while the task is performed.
- Do not place yourself in a position that will expose you to hazards while performing a task.
- Monitor personnel routinely to determine that safe work procedures are followed.
